Manhole Inspection Summary

Manhole # S09WW1016MH

Location Address: **5609 MERVILLE AVE**

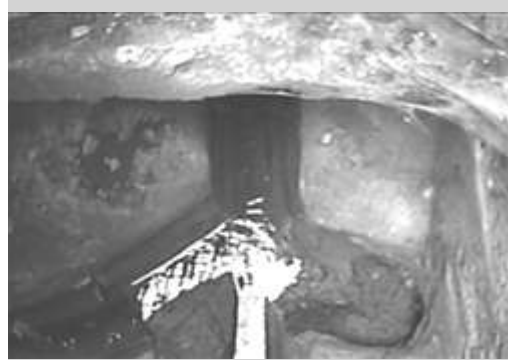
Top View

☒ **Debris** (not Condition related)

Channel debris.

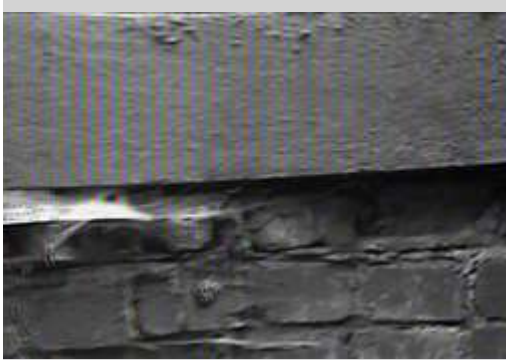
Defect

☒ **Leaks**

Condition: ☐ Sound ☐ Cracked ☐ Root Intrusion ☐ Loose Brick ☒ **Deteriorated**

Infiltration: ☐ None ☒ **Joint** ☐ Cracks ☒ **Mortar** ☐ Roots ☐ Wall

Frame leaks. Frame Adjustment deterioration and infiltration.

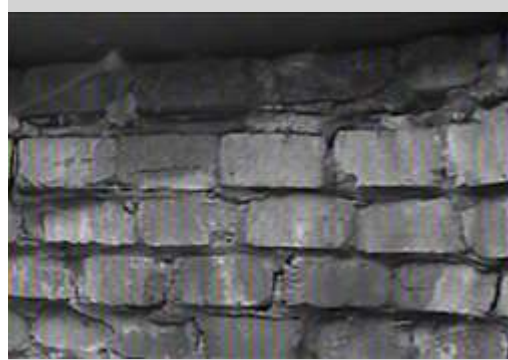
Defect

Condition: ☐ Sound ☐ Cracked ☐ Root Intrusion ☐ Loose Brick ☒ **Deteriorated**

Infiltration: ☐ None ☐ Joint ☐ Cracks ☒ **Mortar** ☐ Roots ☐ Wall

Corbel deterioration and infiltration.

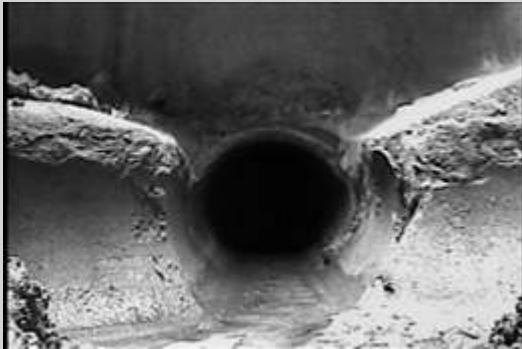
8 in. Circular Gravity Sewer Pipe Out @ 12 O'Clock

Infiltration: **Evidence** Pipe Seal Cond: **Unknown**

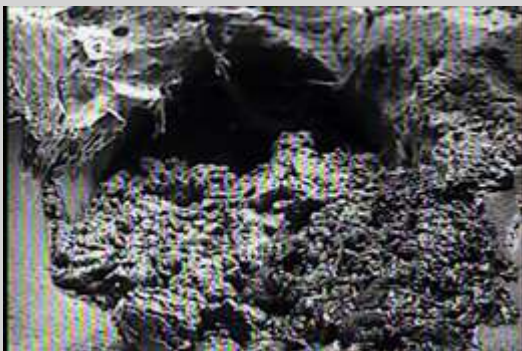
6 in. Circular Gravity Sewer Pipe In @ 3 O'Clock

Channel and pipe debris.

Deposits: ☐ None ☒ **Mud** ☐ Sludge ☐ Debris ☐ Grease

Silt Depth: **3** (in.) Deposits Extent: **Medium**

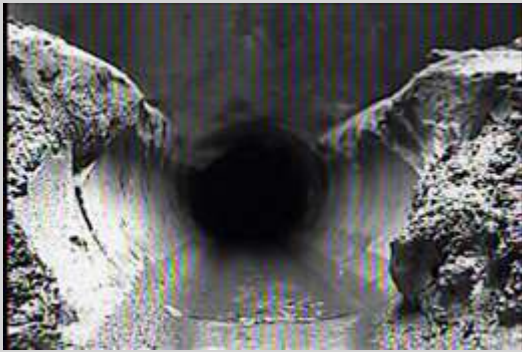
Pipe In @ 6 O'Clock

Infiltration: **Evidence** Pipe Seal Cond: **Unknown**

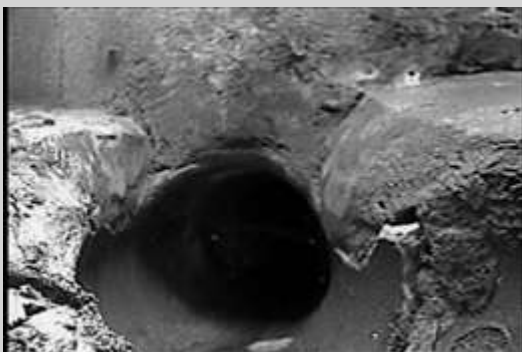
Pipe In @ 9 O'Clock

Infiltration: **Evidence** Pipe Seal Cond: **Unknown**
